FAILURE INFORMATION

SEIZURE NEXT TO THE PISTON PIN BORES (45° SEIZURE MARKS)

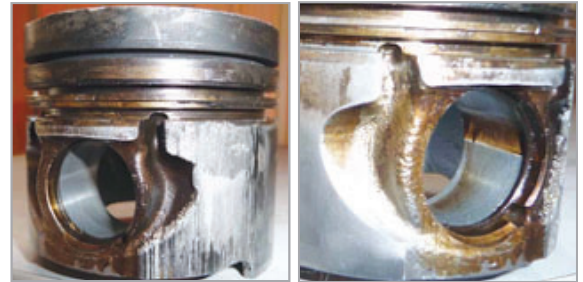
-In such a failure, as seen in Figure 1, the pistons are subject to seizure at 45° of the piston in areas closer to the piston pin bore at the piston skirt.

-There is usually no mark of seizure on contact surfaces of the piston skirt, marks of normal operation are seen on these surfaces.

-The piston pin is not free, it is compressed in the removed connecting rods.

-Marks of seizure can be seen when the piston pin bores are examined.

As the piston pin and the oil film around it is deteriorated and torn, these areas get overheated, unlubricated, dry operation occurs and causes marks of seizure. The causes of unlubricated operation at these areas and heating as a result of tear oil film are;

1 - Connecting rod is assembled defectively in pistons with shrink-fit connecting rods. After the shrink-fit connecting rod is assembled, moving the connecting rod before it is cooled down causes initial seizure and marks of seizure in the pin bore, expansion of unlubricated operation in this area and more important engine failures.

2 - If the piston pin bores and the piston are not lubricated adequately during the engine overhauling operation, marks of seizure due to unlubricated dry operation occur during the initial operation to the vehicle and the marks of seizure in this area proceed and result in engine failure.

3 - Lubrication of the pistons and the cylinder inside the engine is performed by the oil splashed as a result of the connecting rods hitting the oil inside the engine's crankcase. Operating the engine at idle for a long time to heat it up causes decrease in the engine lubrication and dry operation of the piston in the pin bore, accordingly seizure failures inside and around the pin bore.

4 - A sudden loading on a recently-started engine, applying too much force right after starting causes expansion of the piston upon faster heating than the engine liner and as a result, seizure failure around the piston pin bore.

1 - During restoration of the engines, where the connecting rod is assembled as shrink-fit, after the piston and the piston pin are assembled to the heated connecting rod, the connecting rod should not be moved. After the piston, the piston pin and the connecting rod have cooled down, they should be lubricated and it should be checked whether the piston pin moves freely in the piston pin bores.

2 - Oil should be pressurized into the engine and oil should reach every area where oil circulates. The engine's oil pressure should be measured.

3 - The engine should not be operated at idle for a long time. No excessive force should be applied right after the engine start.

4 - The engine brake should not be used too often.

5 - After the engine overhauling operation, instead of idle operation, the vehicle should be driven at medium speed without many stop-and-goes in the traffic.

6- Oil pump should be checked. Faulty oil pump should be replaced.
